NATIONAL AERONAUTICS AND SPACE ADMINISTRATION

APOLLO 9 MISSION REPORT

MANNED SPACECRAFT CENTER

MAY 1969

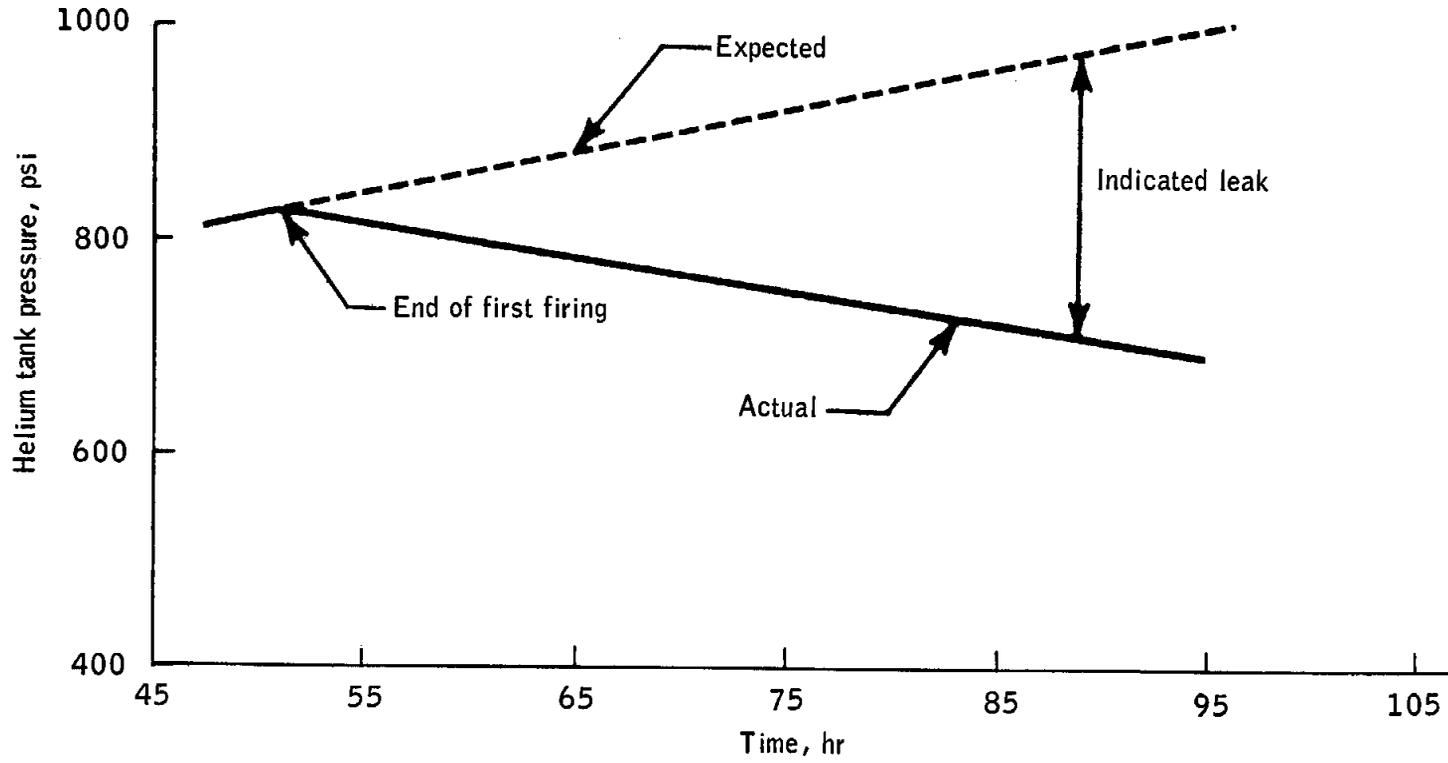
Figure 17-18.- Supercritical helium pressure decay.

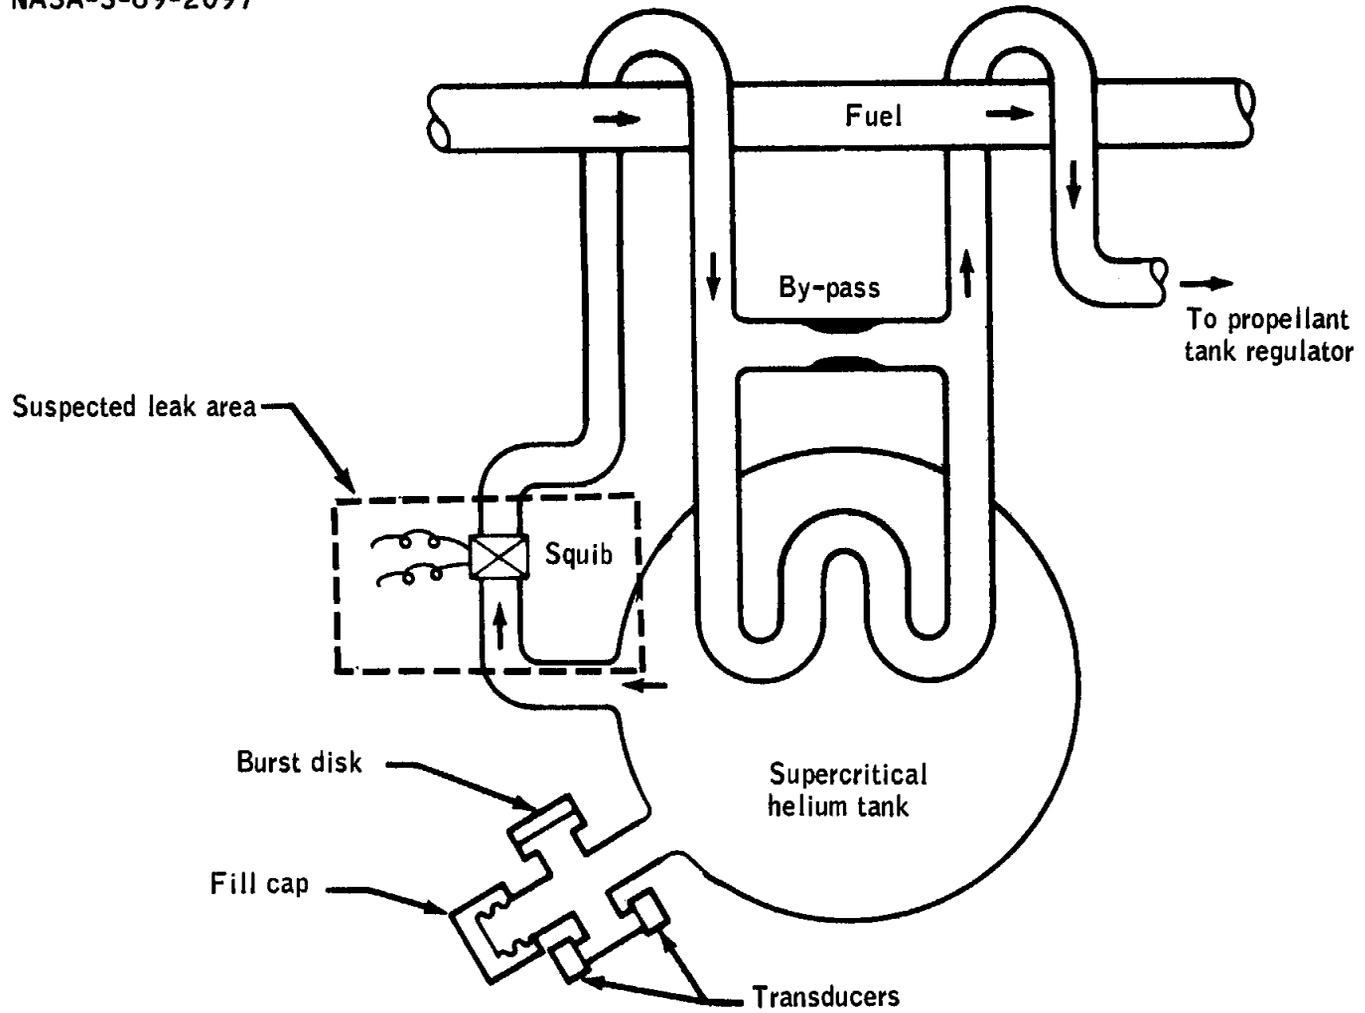
Figure 17-19.- Supercritical helium pressure suspected leak area.

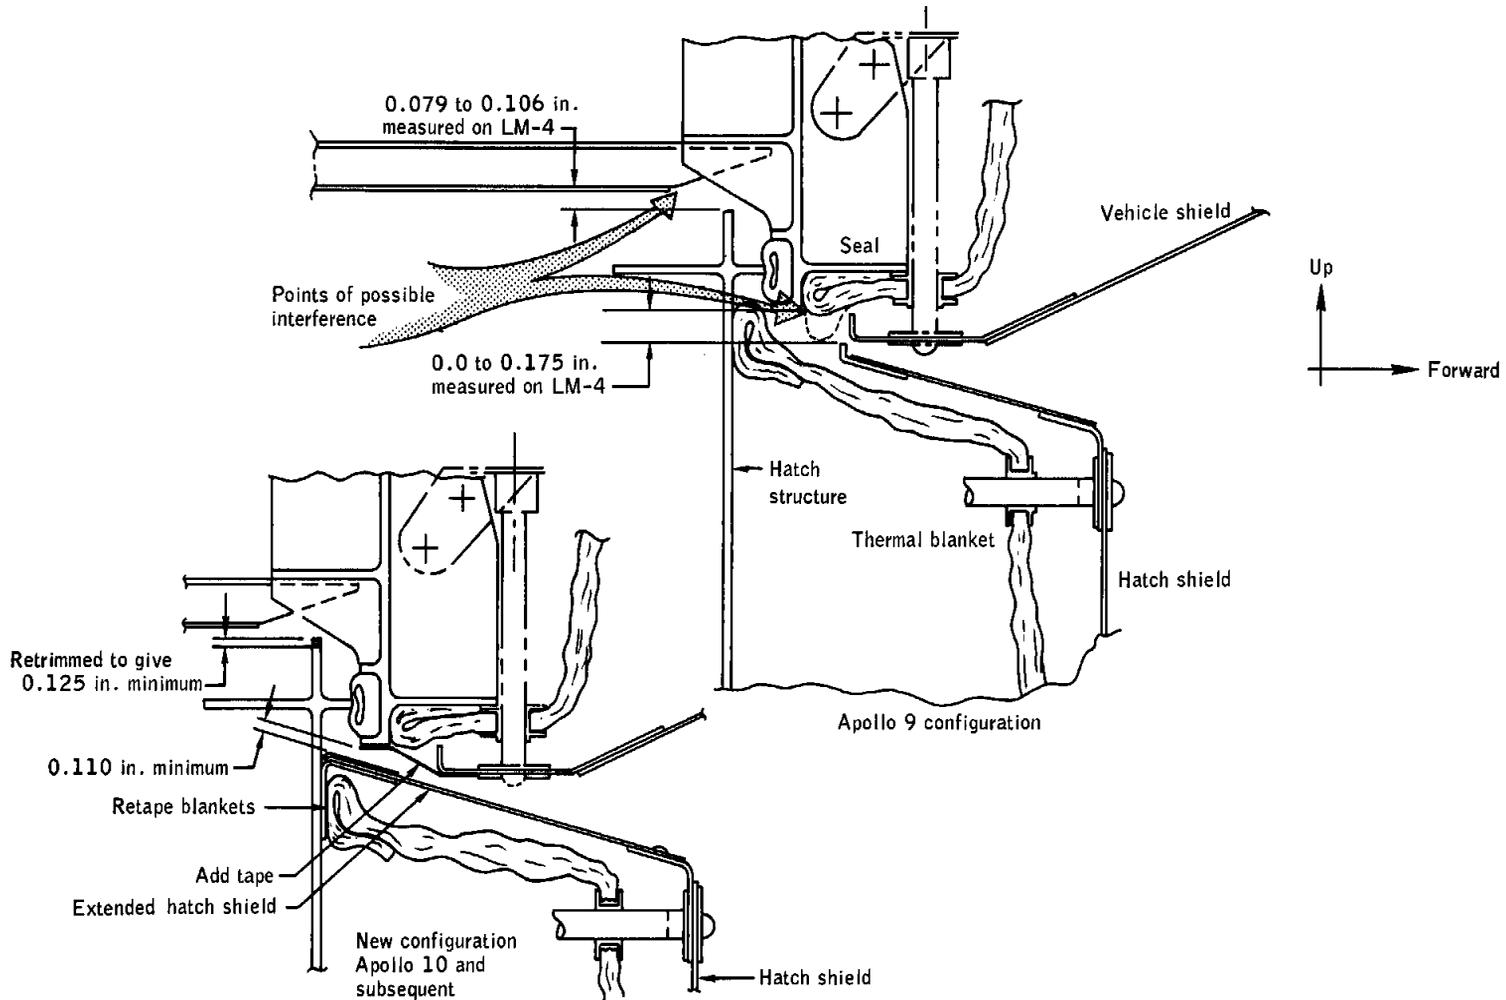
Figure 17-22.- Potential hatch interferences.

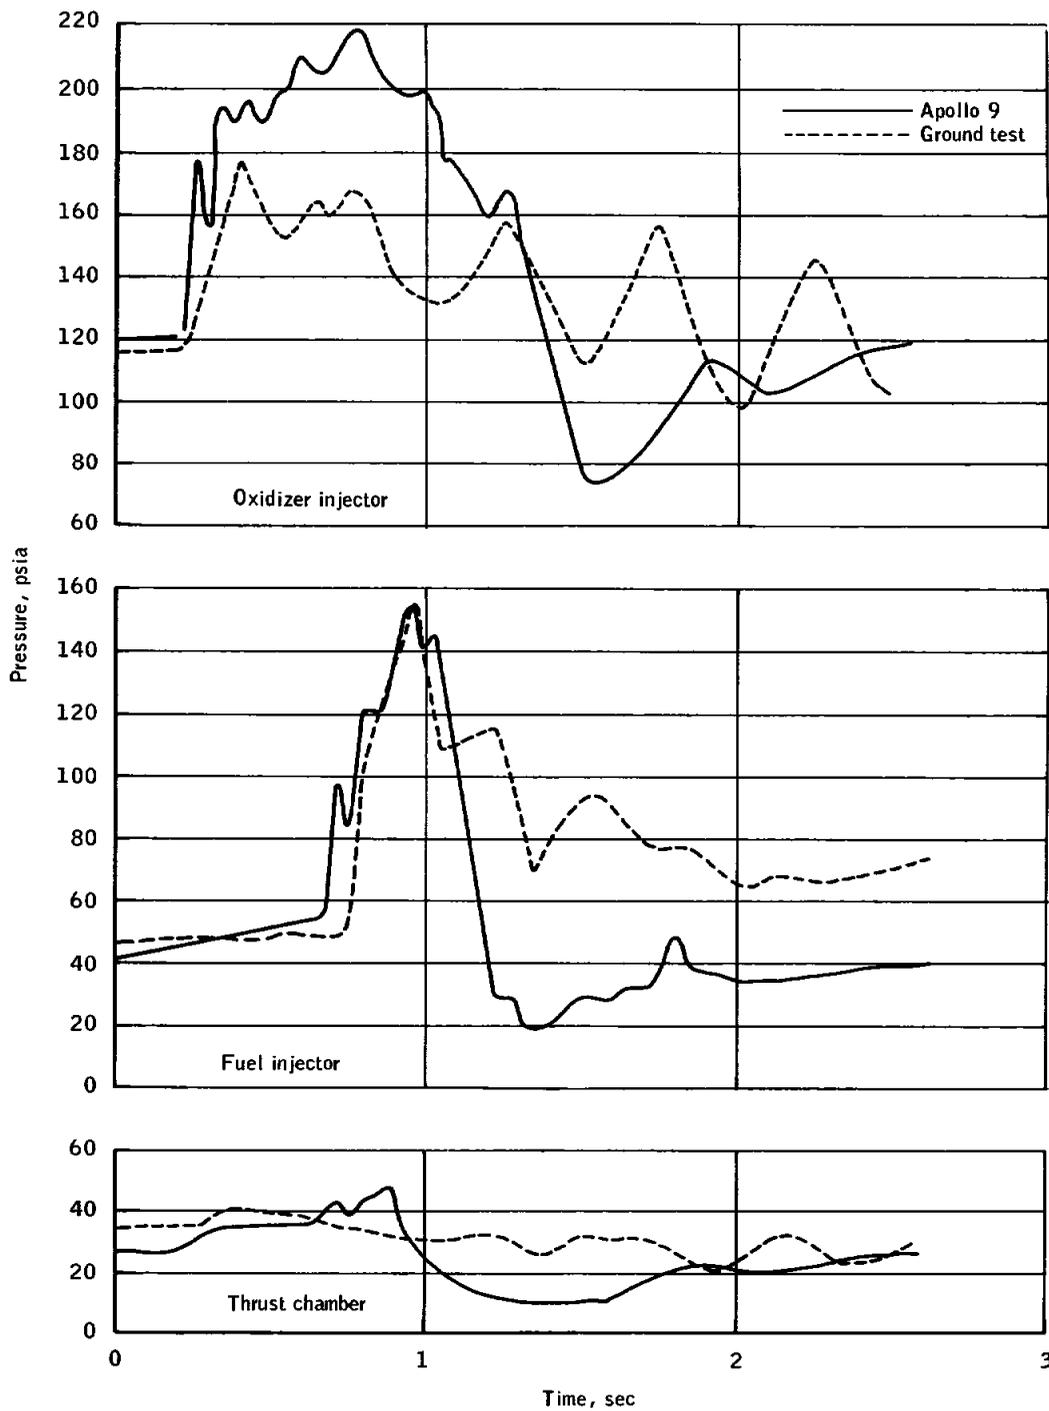
Figure 17-28.- Comparison of roughness during second descent engine firing and ground tests.
